LIVESTOCK INSPECTION DIGITAL PHOTOGRAPH PHOTOCOPIES

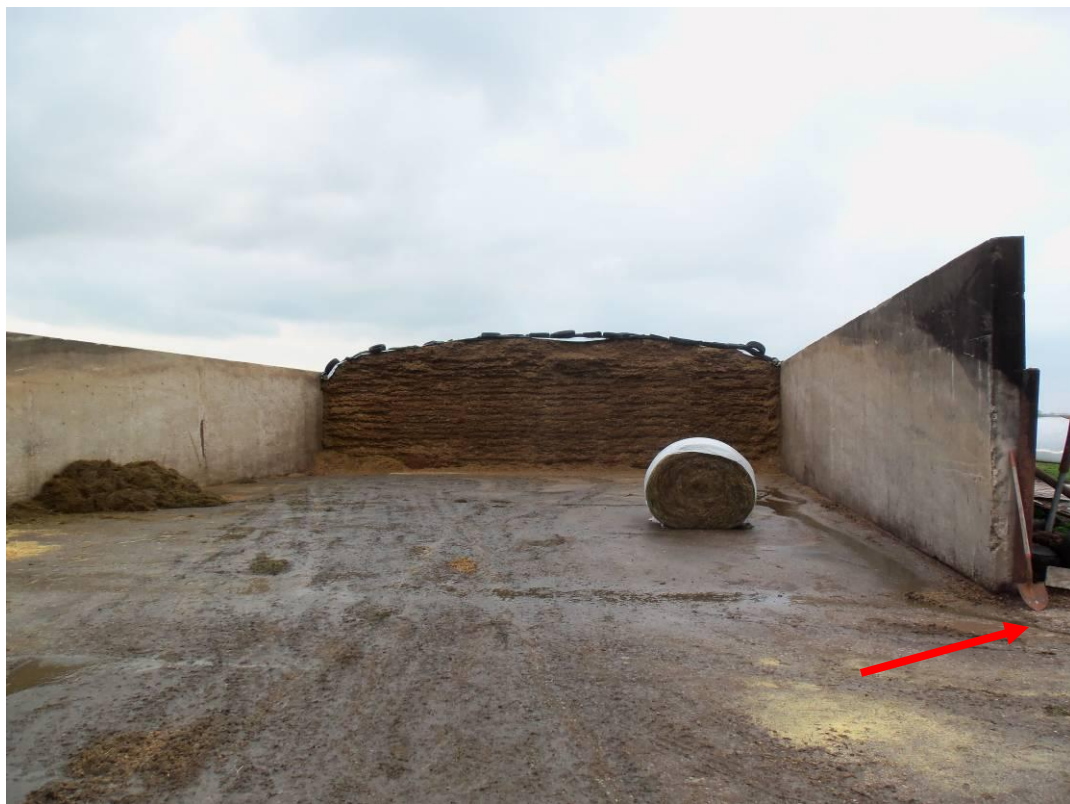
Photo # 001
Date: December 20, 2012
Time: 9:09 a.m.
Taken By: Brian Rodely DWPC/FOS
Facility: VB Family Farms
Location: N Silage Bunker Face S
Notes: Silage bunker is shown
with leachate running out
of the north west corner as
indicated by the red arrow.

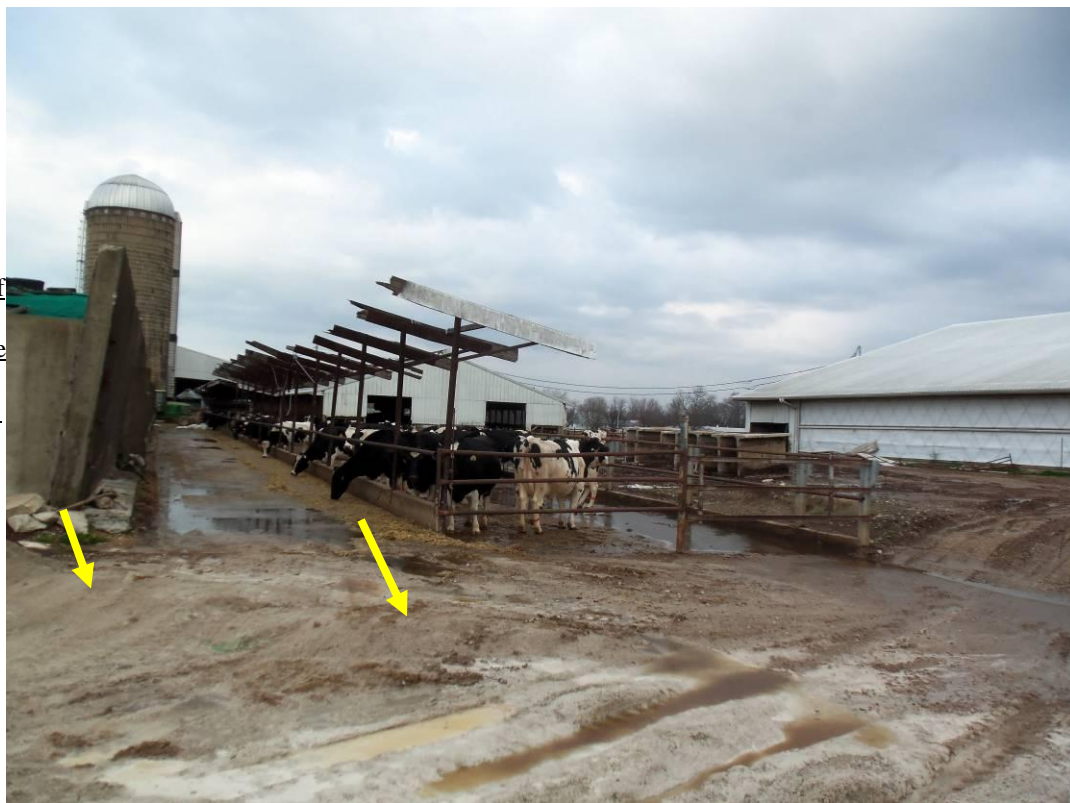
Photo # 002
Date: December 20, 2012
Time: 9:11 a.m.
Taken By: Brian Rodely DWPC/FOS
Facility: VB Family Farms
Location: SE Silage Bunker Face NE
Notes: The diversion berm is
pointed out by the yellow
arrow directing silage
leachate to a grating just off
the photo right. Feedlot
runoff is also directed to the
grating that discharges to
the waste holding structure.

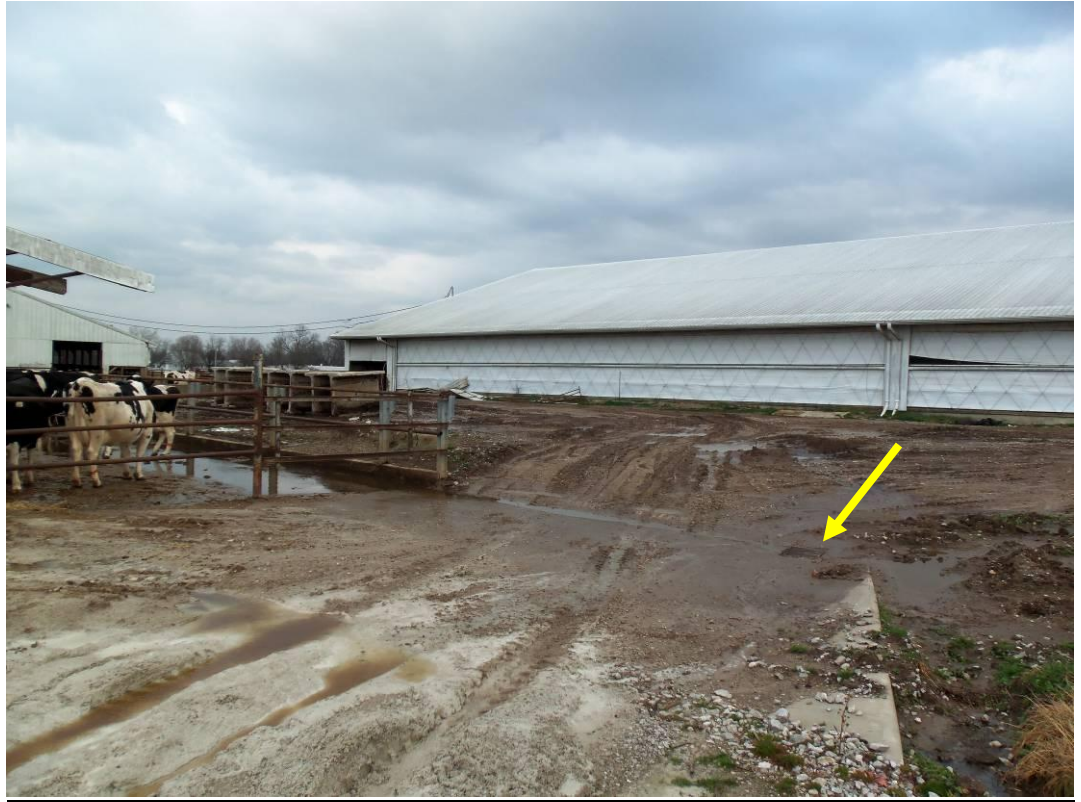
Photo # 003
Date: December 20, 2012
Time: 9:11 a.m.
Taken By: Brian Rodely DWPC/FOS
Facility: VB Family Farms
Location: SE Silage Bunker Face NE
Notes: A grated reception pit that discharges to the waste handling system can be seen in the photo right as indicated with the yellow arrow. Note the feedlot runoff entering the grating.

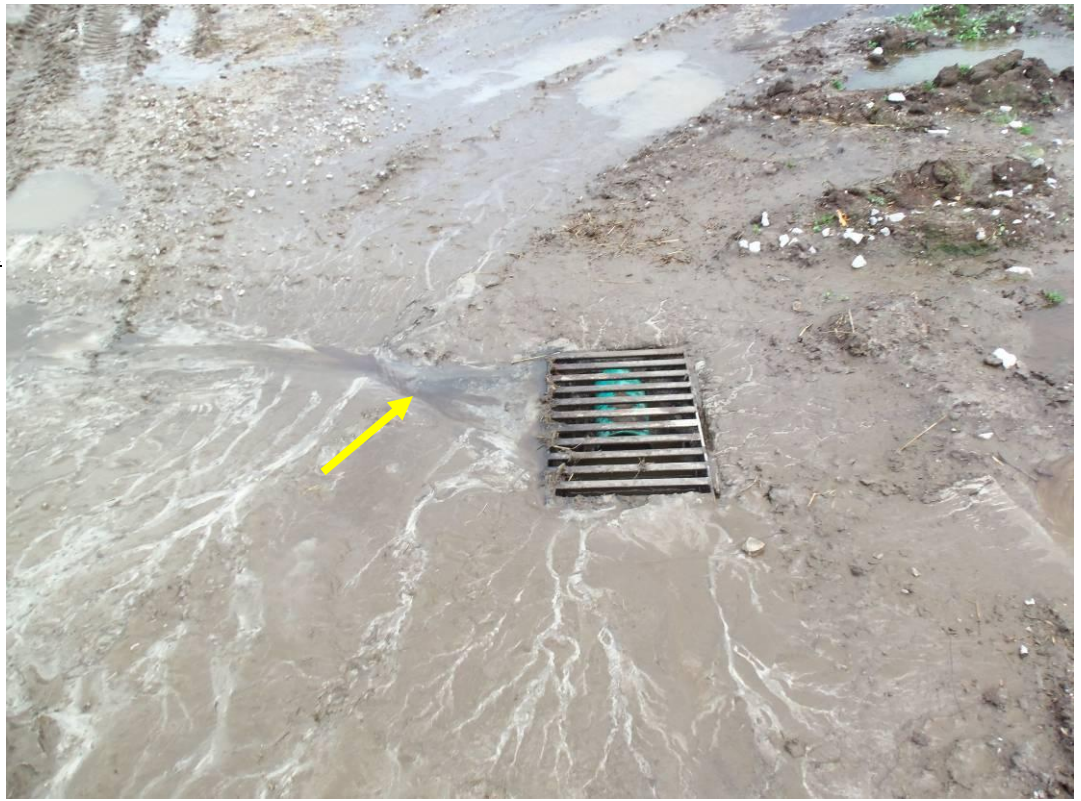
Photo # 004
Date: December 20, 2012
Time: 9:12 a.m.
Taken By: Brian Rodely DWPC/FOS
Facility: VB Family Farms
Location: SE Silage Bunker Face N
Notes: Closeup of the reception grating that receives silage leachate from the south end of the silage bunker. Drainage from the western feedlot also runs to the grating as pointed out by the yellow arrow.

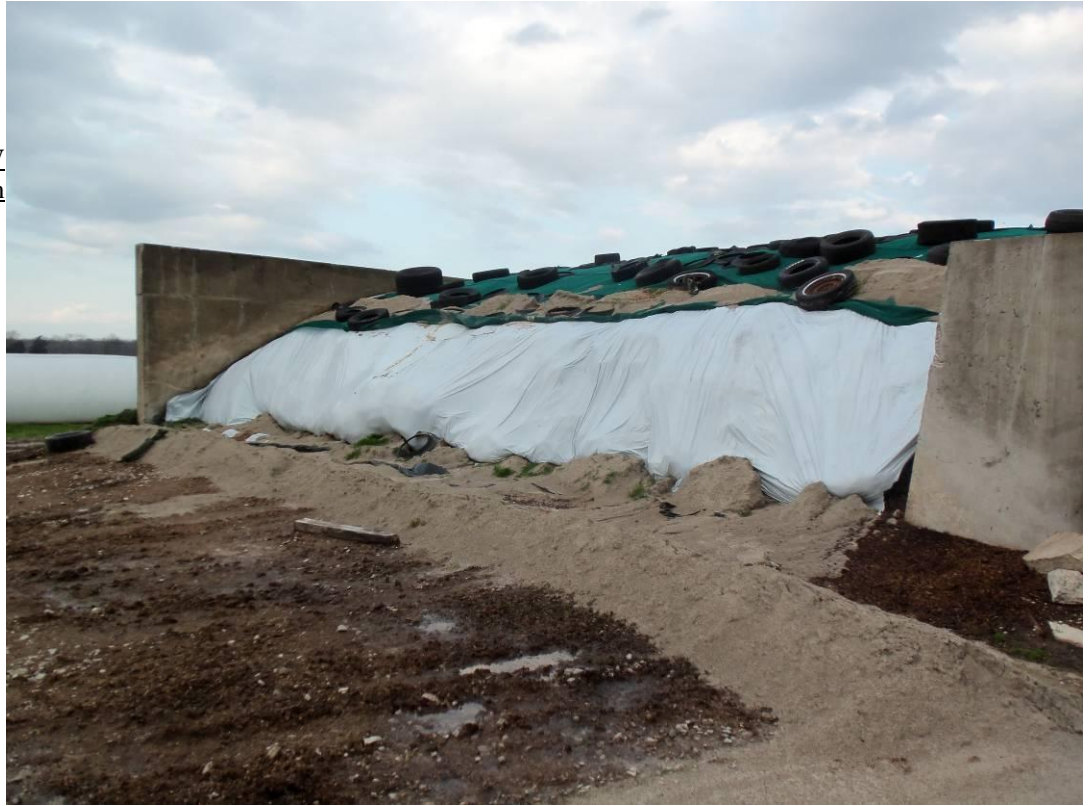
Photo # 005
Date: December 20, 2012
Time: 9:12 a.m.
Taken By: Brian Rodely DWPC/FOS
Facility: VB Family Farms
Location: SE Silage Bunker Face NW
Notes: View of the limestone berm
on the south side of the
silage bunker. Leachate is
directed to the grating
shown in photo 004.

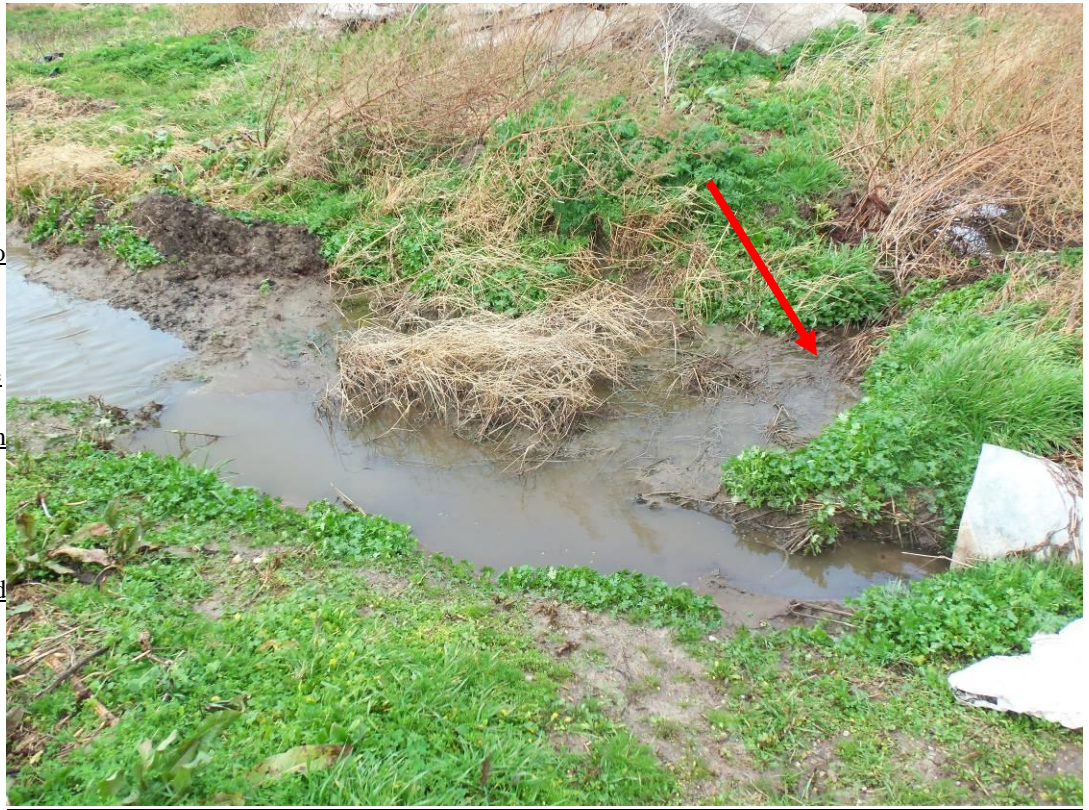
Photo # 006
Date: December 20, 2012
Time: 9:14 a.m.
Taken By: Brian Rodely DWPC/FOS
Facility: VB Family Farms
Location: S Silage Bunker Face NW
Notes: The ditch condition is
shown in the adjacent photo
where a sample was taken
on 05/01/12. The ditch
drains SW across the field
to an unnamed tributary are
shown in the adjacent
photo. Silage leachate from
the SW corner of the silage
bunker crosses the gravel
drive, runs south along the
silage bags, and enters the
ditch as indicated by the red
arrow.

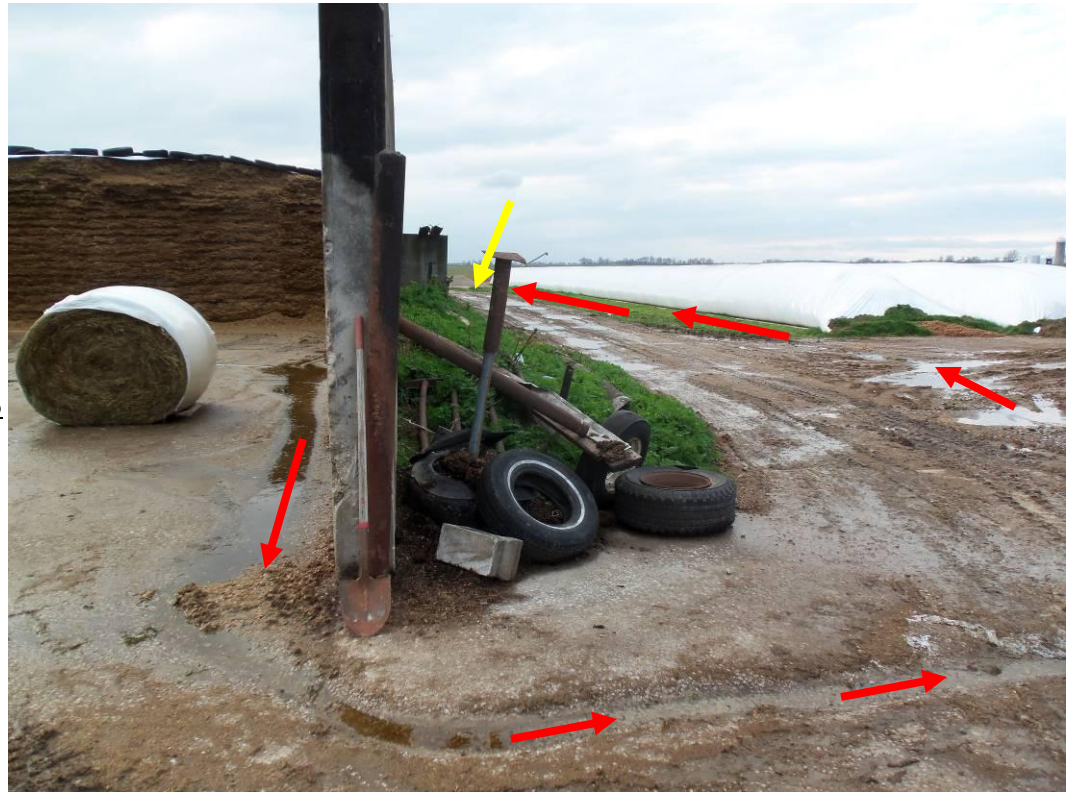
Photo # 007
Date: December 20, 2012
Time: 9:31 a.m.
Taken By: Brian Rodely DWPC/FOS
Facility: VB Family Farms
Location: N Silage Bunker Face S
Notes: Pictured to the right is a view of the leachate migrating north along the west wall of the silage bunker, then west along a trench across the gravel drive, then south a alongside the silage bags to the ditch shown in photo 006 as indicated by the yellow arrow. Note the spade tip shovel leaning on the silage wall that appears to be the correct size to maintain the drainage trench across the gravel.

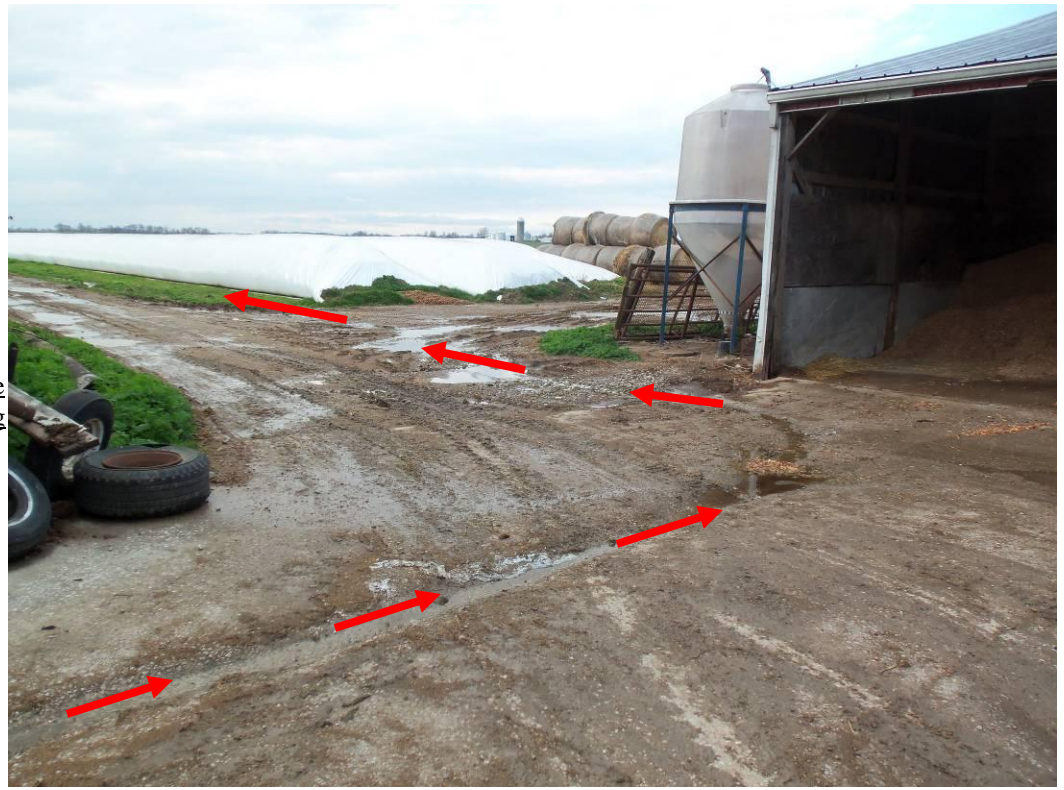
Photo # 008
Date: December 20, 2012
Time: 9:31 a.m.
Taken By: Brian Rodely DWPC/FOS
Facility: VB Family Farms
Location: N Silage Bunker Face SW
Notes: Red arrows show the drainage path of the leachate exiting the north west corner of the silage bunker. The leachate follows a drainage trench west across the gravel drive turning south running along the silage bags to a ditch shown in photo 006.
